# Home Inspection Report

OF THE PROPERTY AT

5555 Canterbury Ln., Gurnee, IL.

Tuesday, October 7, 2014

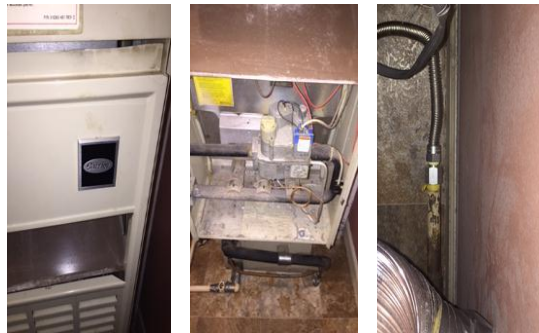
**Interior:** - Recommend budgeting for replacement of furnace and water heater – past life expectancy and very dirty. Also, recommend installing gas shut off to dryer – none present.

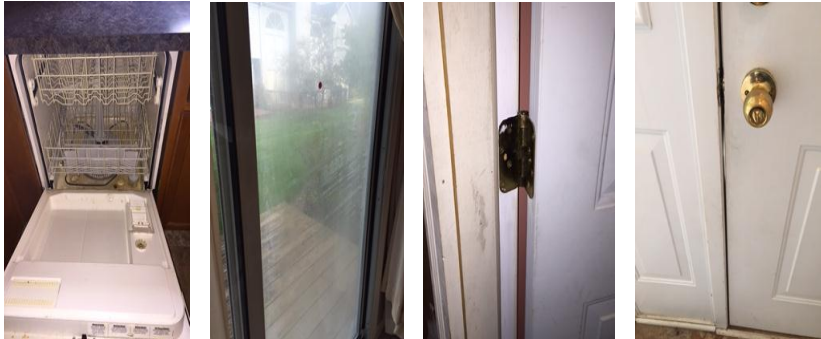
- Recommend correcting dishwasher – not working properly, correcting patio door and living room window with broken thermal seals. Also recommend installing automatic self closing hinges on garage door and install weather stripping on main front door – open gap.

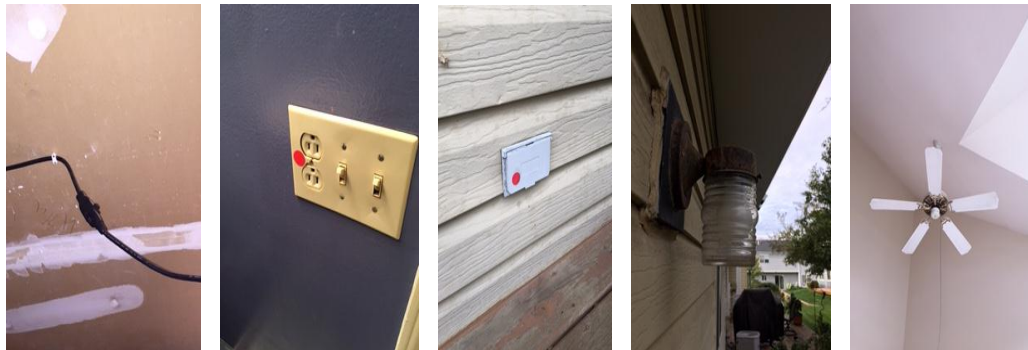
- Recommend installing direct outlet for garage door opener (not extension cord), properly securing loose outlet in powder bathroom and correcting exterior outlet on deck – no power. Also recommend correcting exterior light fixture by deck – did not turn on and correcting living room and master bed ceiling fans – not working properly.
